HOME INSPECTION

## Inspection Report

**Property Address:**  
5555 NE Portland View Dr.  
Portland OR 55555

<b>Date:</b> 9/13/2011	<b>Time:</b> 10:00 AM	<b>Report ID:</b> Sample Report
<b>Property:</b> 5555 NE Portland View Dr. Portland OR 55555	<b>Customer:</b> John Doe	<b>Real Estate Professional:</b>

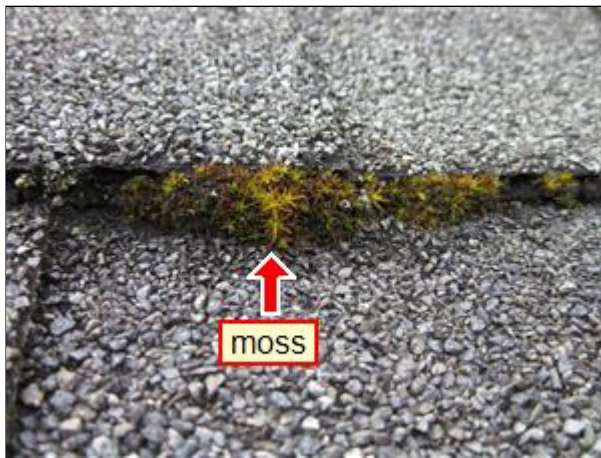
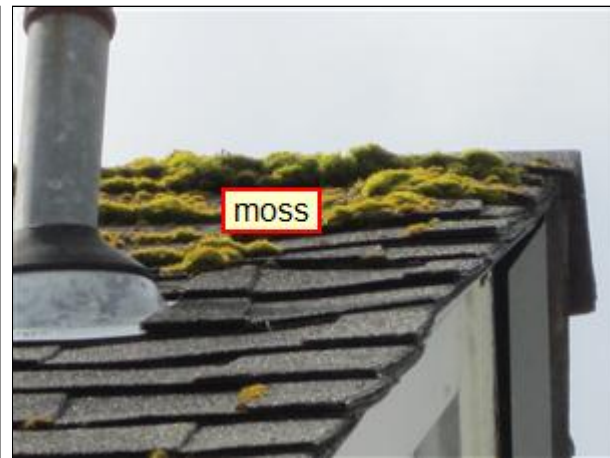
1.0 Picture 1

**1.0** There is significant moss build up on the roof. The moss can impede water runoff and its root system can start to lift the shingles leading to a premature failure of the roof covering. It is recommended that the moss be removed and a moss inhibitor be applied to the roof.

There is significant moss build up on the roof. The moss can impede water runoff and its root system can start to lift the shingles leading to a premature failure of the roof covering. It is recommended that the moss be removed and a moss inhibitor be applied to the roof.

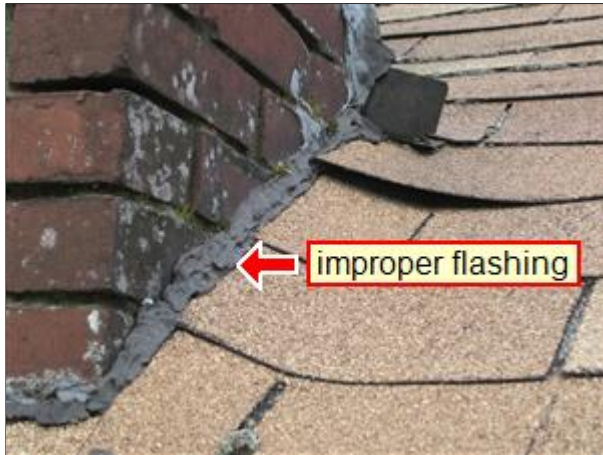
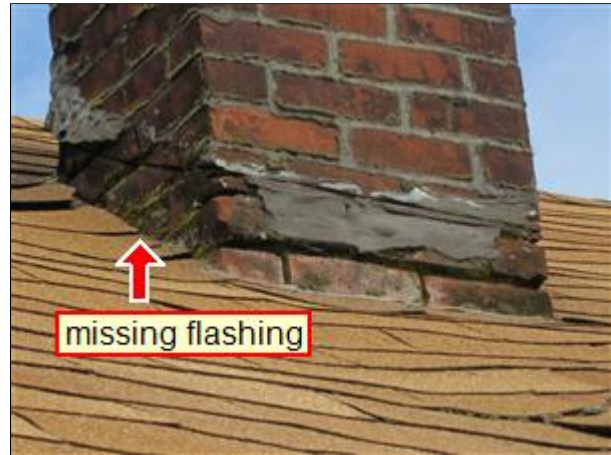
1.1 Picture 1

**1.1** The roof flashing is rusted in places, installed incorrectly, and missing around chimneys. Roofing tar has been used around chimneys. This is only a temporary fix because over time the tar will become brittle and crack making it not function properly. Proper flashing should be installed around chimneys and existing old flashings should be replaced.

The roof flashing is rusted in places, installed incorrectly, and missing around chimneys. Roofing tar has been used around chimneys. This is only a temporary fix because over time the tar will become brittle and crack making it not function properly. Proper flashing should be installed around chimneys and existing old flashings should be replaced.

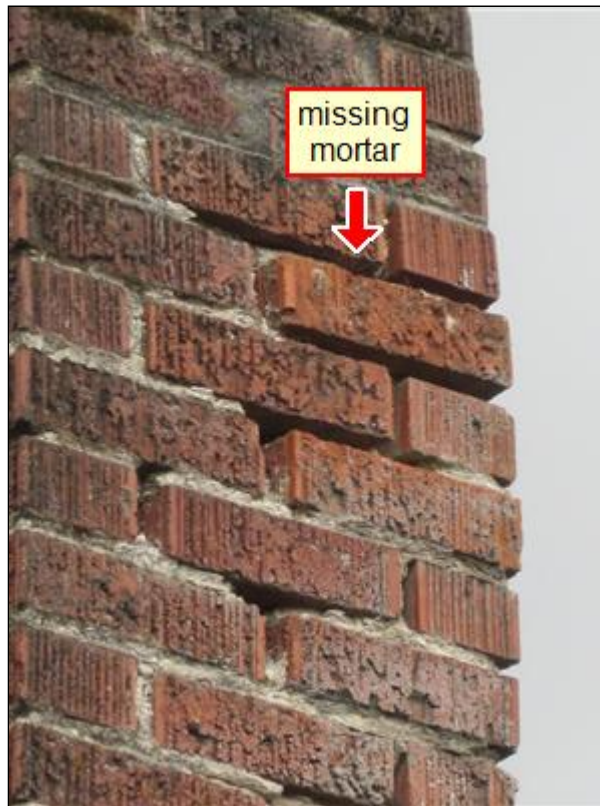
1.3 Picture 1

**1.3** Mortar is missing between bricks of chimney. This can cause leaks and compromise the structural integrity of the chimney itself. Chimney should be tuck pointed to repair problem.

Mortar is missing between bricks of chimney. This can cause leaks and compromise the structural integrity of the chimney itself. Chimney should be tuck pointed to repair problem.

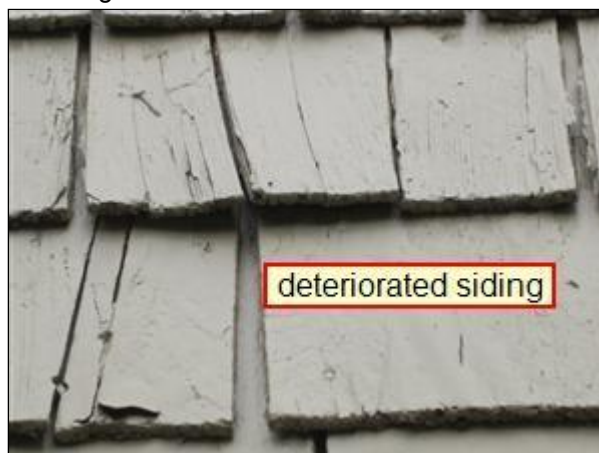
2.1 Picture 1

2.1 (1) The cedar shingle siding has deteriorated at many places on the house. The damaged shingles should be repaired to prevent water intrusion and further damage.

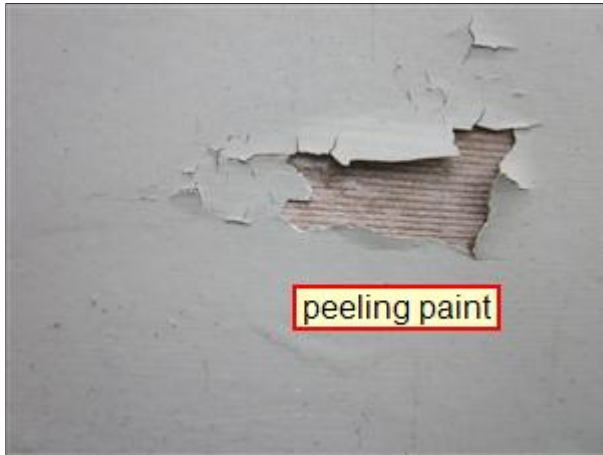
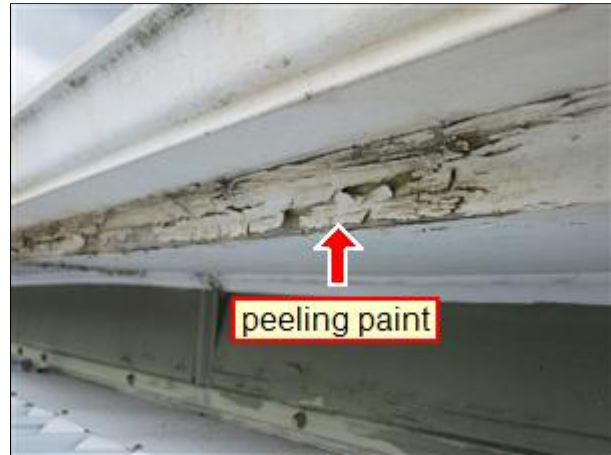
2.1 Picture 2

(2) The paint is peeling on the exterior trim and walls. Unprotected wood can lead to rot and needed replacement. The walls and trim should be scrapped where needed and re-primmed and painted to prolong the life of the siding.

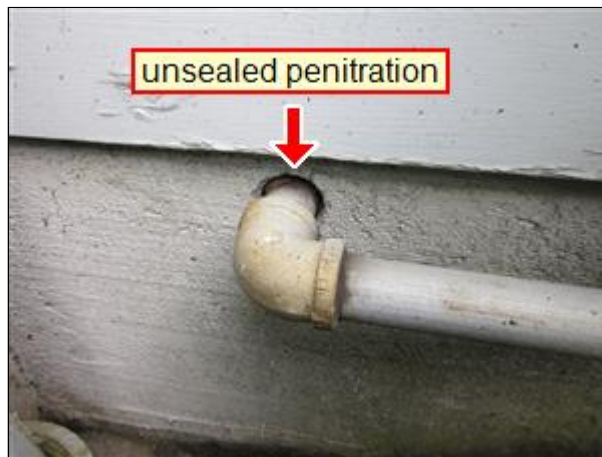
2.1 Picture 4

(3) There is a unsealed penetrations on the south side of the house. This opening can provide a pathway for water and wood destroying insects. These area should be sealed with an exterior caulk.

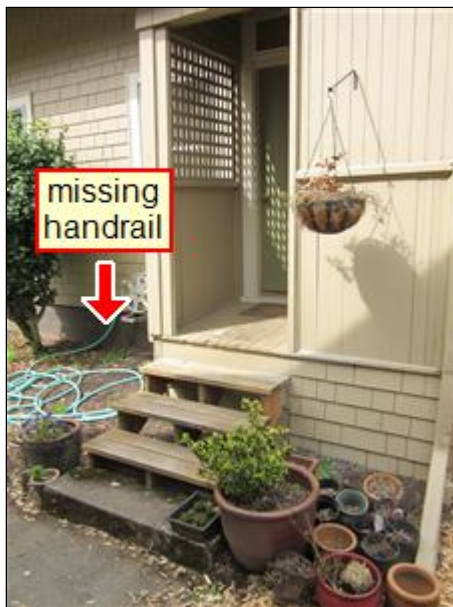
2.4 Picture 1

**2.4 (1)** The back porch steps are missing a handrail. This could be a falling hazard and should be corrected by a qualified contractor.

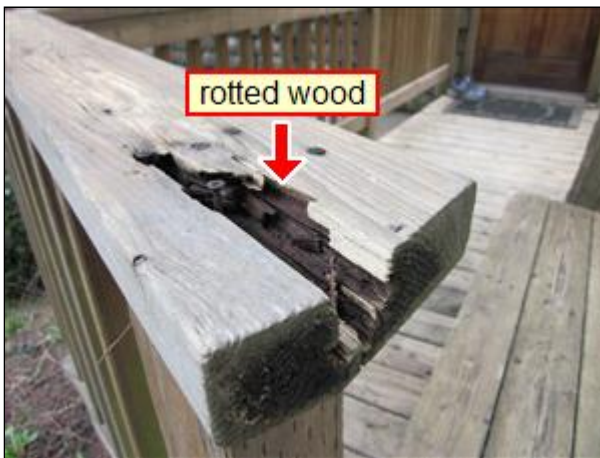
2.4 Picture 2

**(2)** The deck railing at the rear of the home is rotted. The handrail could fail and needs to be replaced before further deterioration could occur.

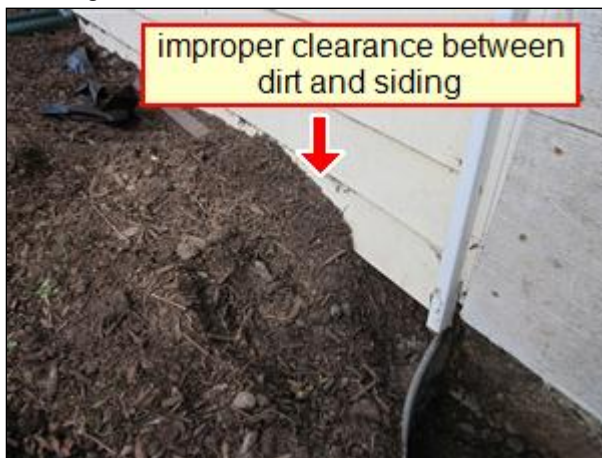
2.5 Picture 1

**2.5** There should be a clearance of at least eight inches between the ground and siding. This prevents the moisture in dirt from rotting the siding and also prevents a direct pathway for wood destroying insects. The ground surrounding the foundation wall should be sloped away from the house as much as possible to prevent water from entering the basement. These issues can be addressed by creating a french drain or swale around areas that are not graded properly.

There should be a clearance of at least eight inches between the ground and siding. This prevents the moisture in dirt from rotting the siding and also prevents a direct pathway for wood destroying insects. The ground surrounding the foundation wall should be sloped away from the house as much as possible to prevent water from entering the basement. These issues can be addressed by creating a french drain or swale around areas that are not graded properly.

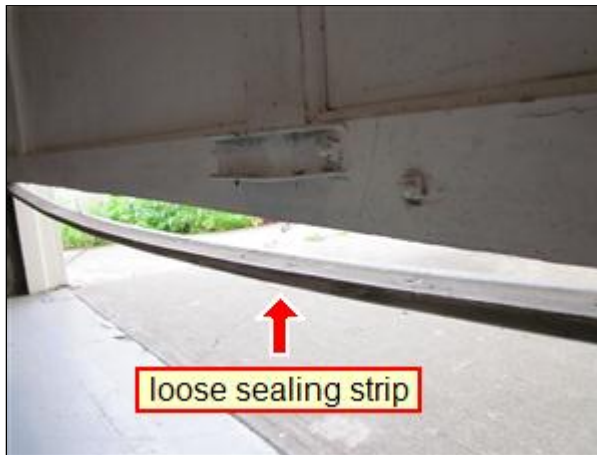
3.4 Picture 1

**3.4** The sealing strip on the garage door is coming loose. This should be reattached to prevent water intrusion.

The sealing strip on the garage door is coming loose. This should be reattached to prevent water intrusion.

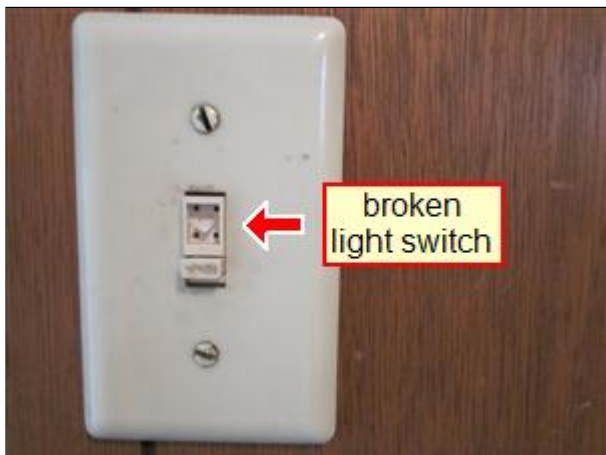
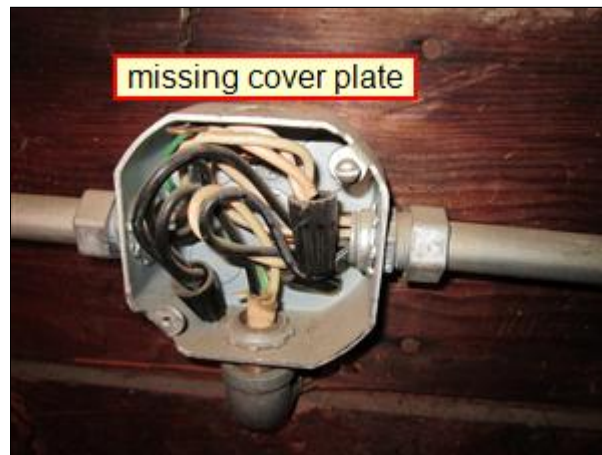
3.6 Picture 1

3.6 There is a broken light switch and a junction box missing a cover plate in the garage. This should be repaired by a qualified contractor.

There is a broken light switch and a junction box missing a cover plate in the garage. This should be repaired by a qualified contractor.

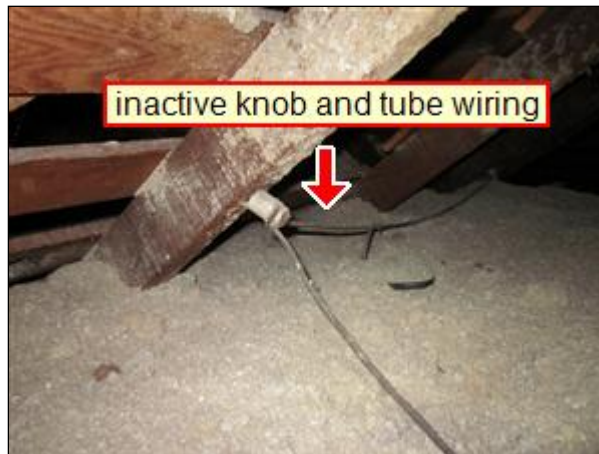
4.1 Picture 1

**4.1** There is old knob and tube wiring in the attic. It was inactive during the time of the inspection. All inactive wiring should be removed to make sure it stays inactive.

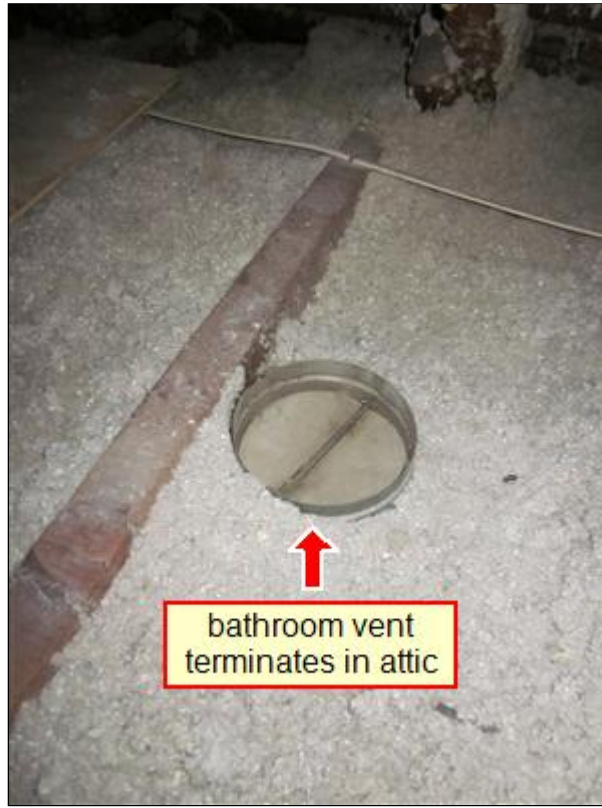
4.4 Picture 1

**4.4** The main floor bathroom vent exhausts directly into the attic. The warm moist air from the bathroom can cause moisture issues in the attic. This can lead to mold and delamination of the roof sheathing. The ventilation ductwork should continue to the roof and be connected to a gable vent.

The main floor bathroom vent exhausts directly into the attic. The warm moist air from the bathroom can cause moisture issues in the attic. This can lead to mold and delamination of the roof sheathing. The ventilation ductwork should continue to the roof and be connected to a gable vent.

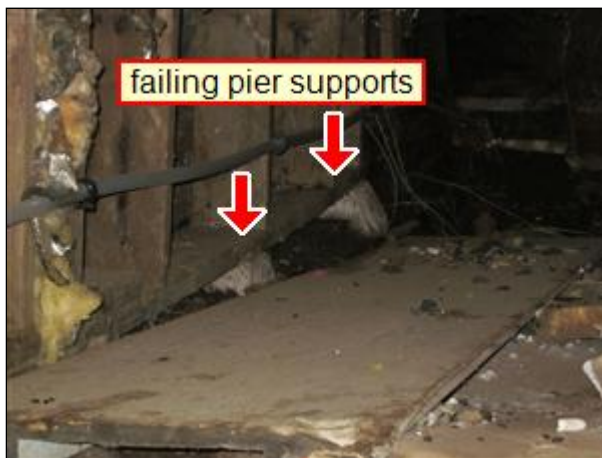
5.1 Picture 1

**5.1** The pier supports at the front and sides of home are failing. This condition can cause the wall to settle more or possibly fail. The walls may need reinforcement and repairs are needed. This has lead the front of the house to settle unevenly with the back of the house with concrete foundation walls. A qualified licensed general contractor should inspect further and repair as needed.

The pier supports at the front and sides of home are failing. This condition can cause the wall to settle more or possibly fail. The walls may need reinforcement and repairs are needed. This has lead the front of the house to settle unevenly with the back of the house with concrete foundation walls. A qualified licensed general contractor should inspect further and repair as needed.

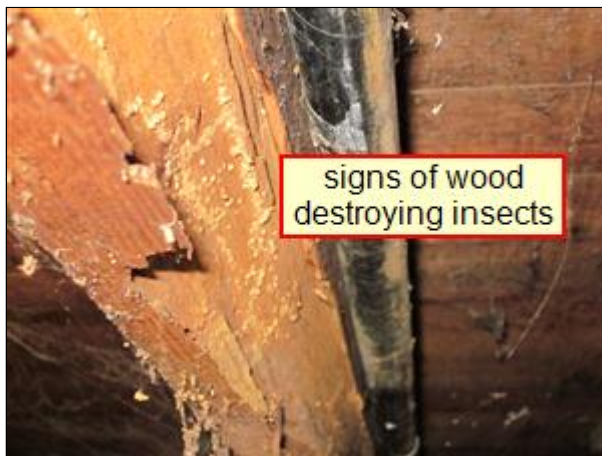
5.8 Picture 1

**5.8** There are visible signs of wood destroying insects in the framing of the basement. The affected areas should be examined and repaired by a qualified contractor. The house should also be evaluated and treated by a pest contractor.

There are visible signs of wood destroying insects in the framing of the basement. The affected areas should be examined and repaired by a qualified contractor. The house should also be evaluated and treated by a pest contractor.

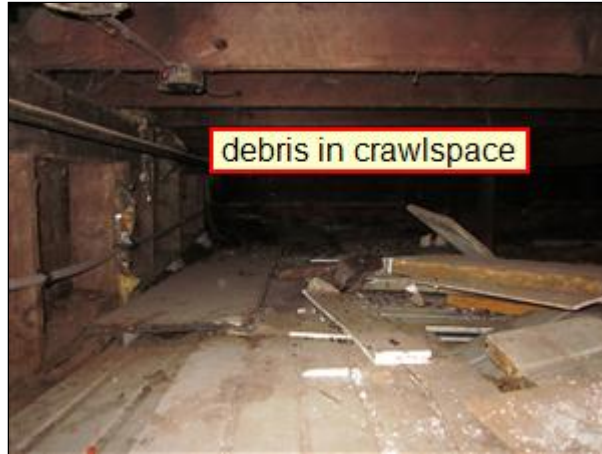
5.9 Picture 1

**5.9** There is debris in the crawlspace and signs of vermin. This debris can become food and shelter for insects and vermin. All debris should be removed.

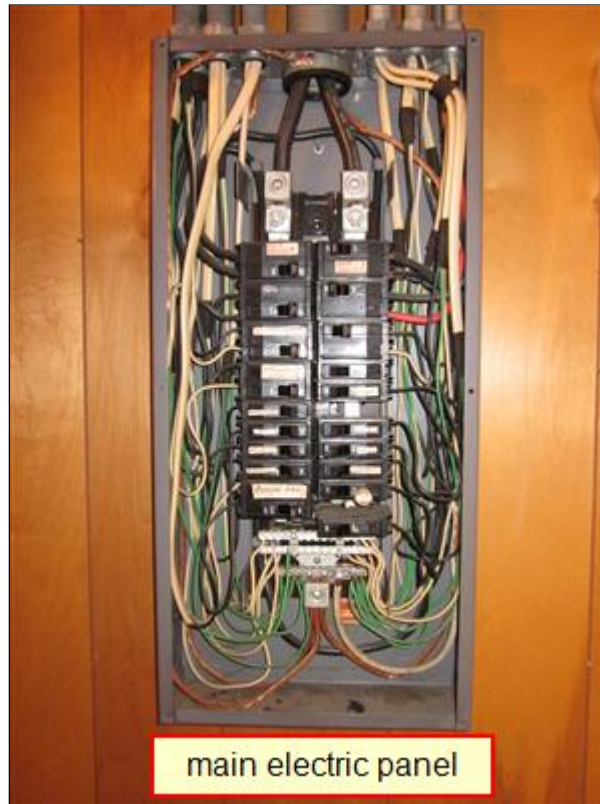
6.0 Picture 1

**6.0** The main electric service panel is located in the basement.

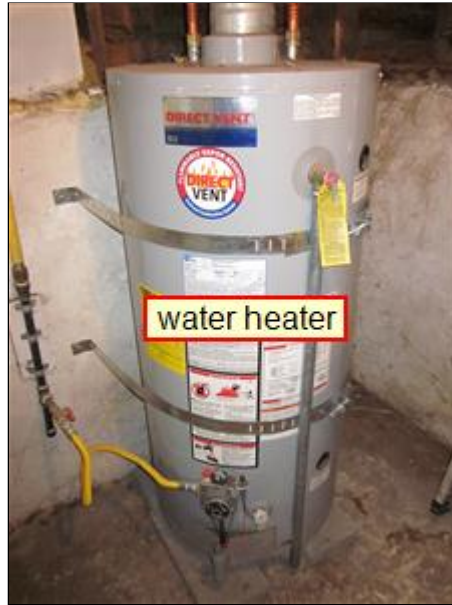
7.0 Picture 1

7.0 2001 American Water Heater Model# DVG62-40S38-NV Serial# 0112100077

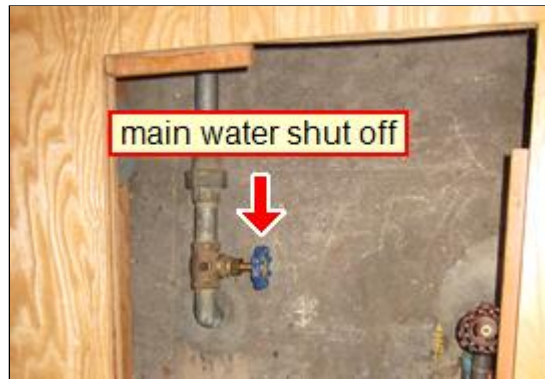
7.1 Picture 1

7.1 The main water shut off is in the basement in back bedroom behind access panel.

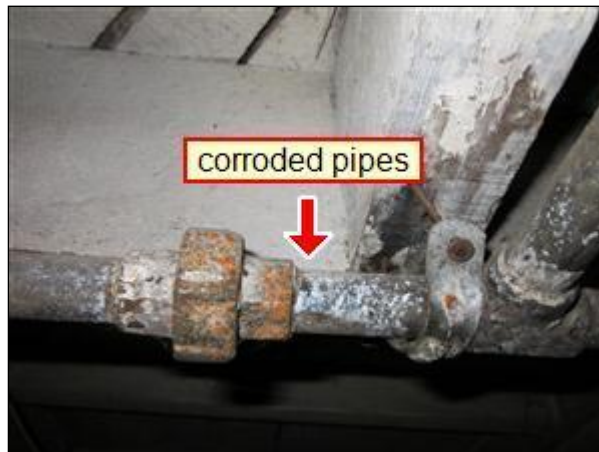
7.3 Picture 1

7.3 The water supply pipes are old galvanized steel. These pipes have deteriorated and could start leaking. All water supply pipes should be further evaluated and repaired by a qualified contractor.

The water supply pipes are old galvanized steel. These pipes have deteriorated and could start leaking. All water supply pipes should be further evaluated and repaired by a qualified contractor.

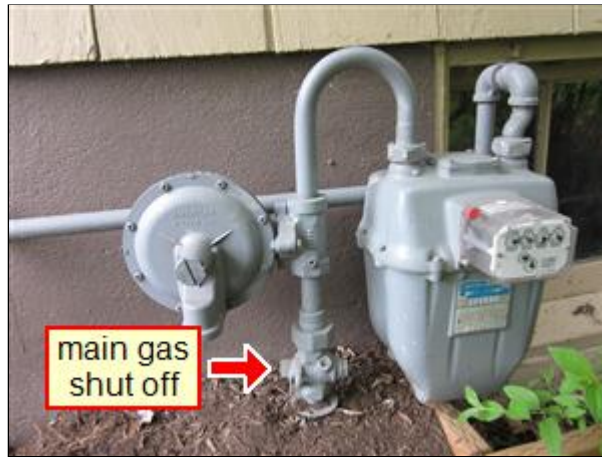
7.8 Picture 1

7.8 The main fuel shut off is at gas meter outside.

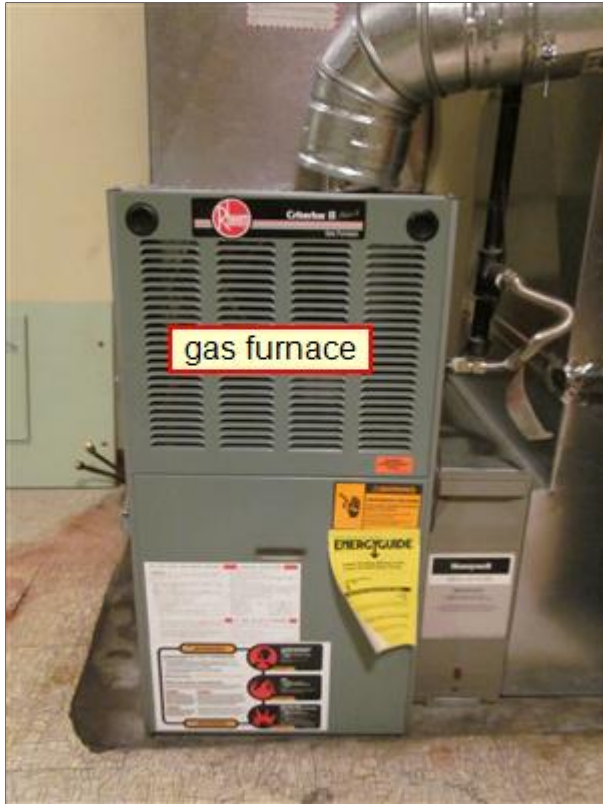
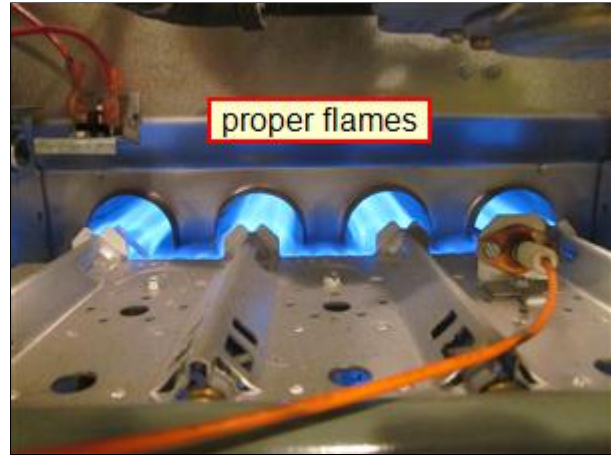
8.0 Picture 1

8.0 1999 Rheem Gas Furnace Model# RGPK-10EAMER Serial# EX5D 302F479903806

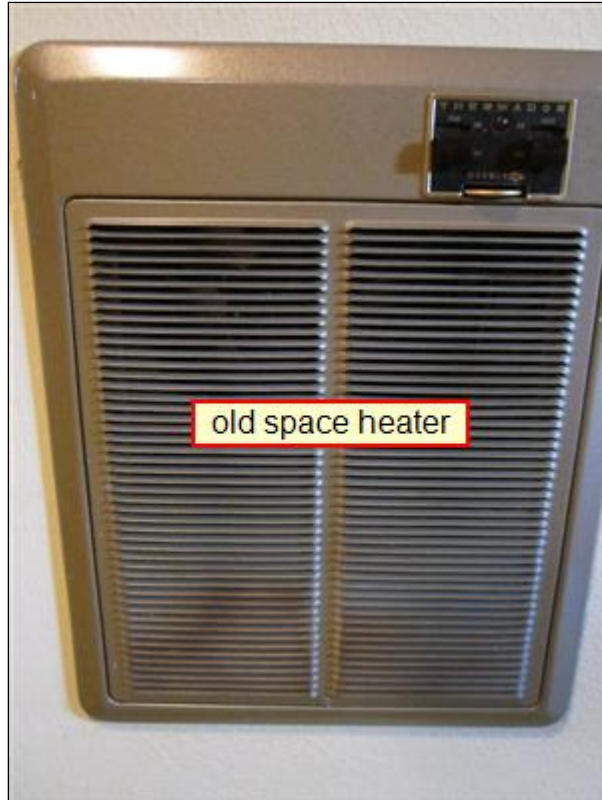
8.1 Picture 1

8.1 There are electric space heaters in the upstairs bedrooms and one in the basement. These are very old and one of them started smoking when turned on. I recommend that these be replaced by a qualified contractor.

There are electric space heaters in the upstairs bedrooms and one in the basement. These are very old and one of them started smoking when turned on. I recommend that these be replaced by a qualified contractor.

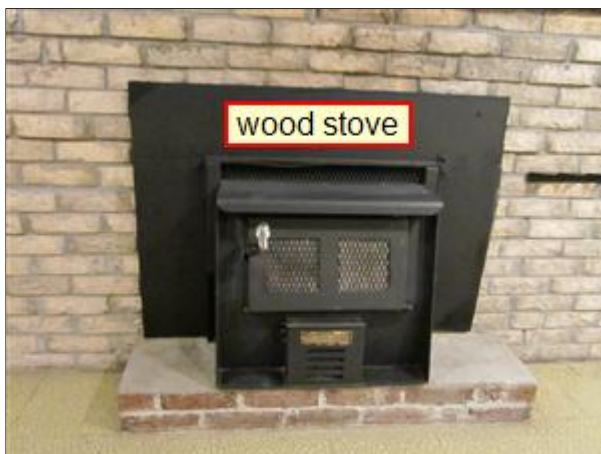
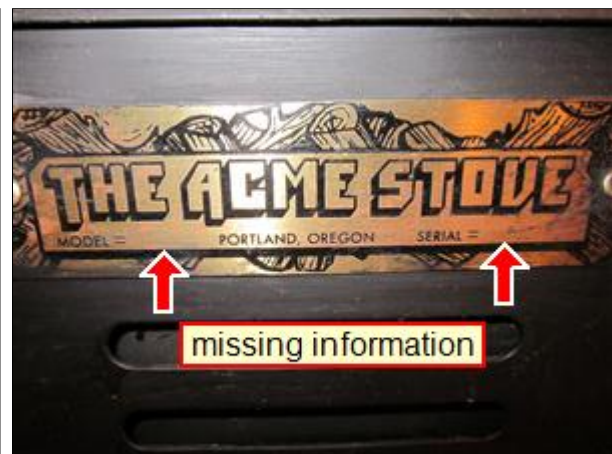
8.8 Picture 1

8.8 The wood burning stove in the basement is very old and is missing model, serial, and certification numbers. This stove may need to be removed by the current owner based on new State of Oregon Laws. Please consult your realtor regarding this issue. For further information follow this link [www.deq.state.or.us/aq/burning/woodstoves/heatSmart.htm](http://www.deq.state.or.us/aq/burning/woodstoves/heatSmart.htm)

The wood burning stove in the basement is very old and is missing model, serial, and certification numbers. This stove

may need to be removed by the current owner based on new State of Oregon Laws. Please consult your realtor regarding this issue. For further information follow this link [www.deq.state.or.us/aq/burning/woodstoves/heatSmart.htm](http://www.deq.state.or.us/aq/burning/woodstoves/heatSmart.htm)

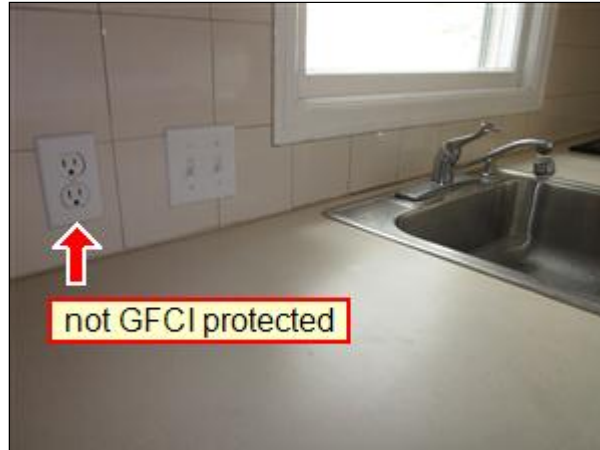
9.8 Picture 1

**9.8** The outlets in the kitchen need to be GFCI protected. A qualified licensed electrical contractor should correct as needed.

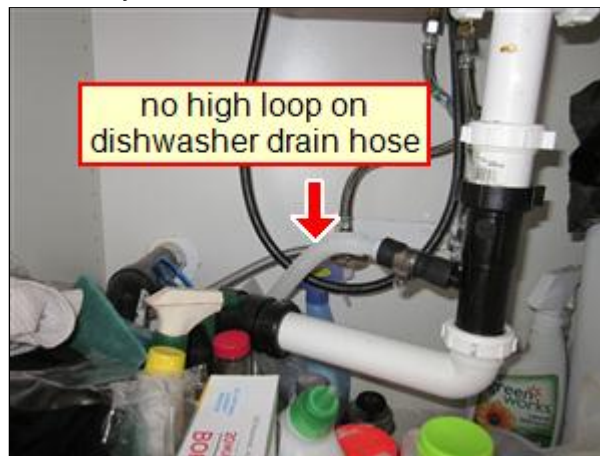
9.9 Picture 1

**9.9** The dishwasher drain hose did not perform a loop to create a trap under sink. This prevents dirty water to re-enter the dishwasher. I recommend repair as necessary.

The dishwasher drain hose did not perform a loop to create a trap under sink. This prevents dirty water to re-enter the dishwasher. I recommend repair as necessary.

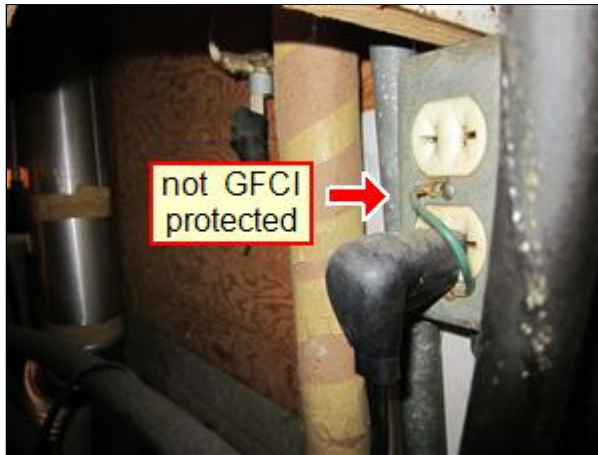
10.6 Picture 1

**10.6** The outlets in the laundry room need to be GFCI protected. A qualified contractor should correct as needed.

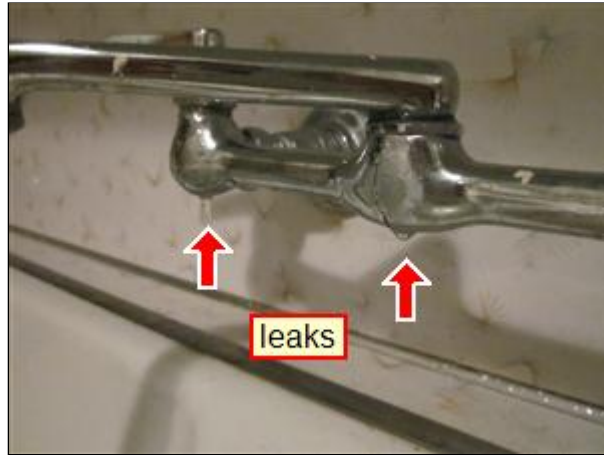
10.8 Picture 1

10.8 The water faucet for the laundry sink was leaking when turned on. This should be repaired by a qualified contractor.

The water faucet for the laundry sink was leaking when turned on. This should be repaired by a qualified contractor.

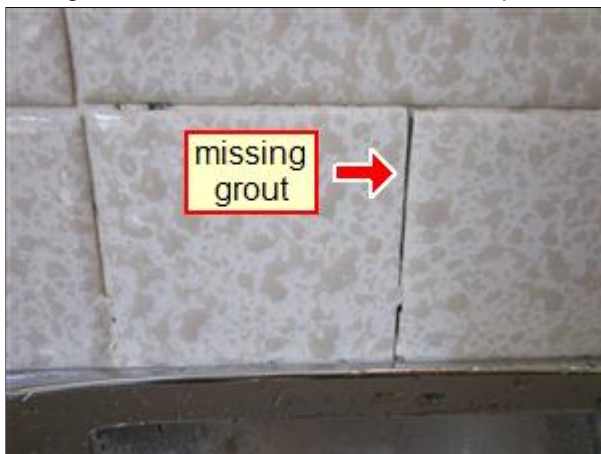
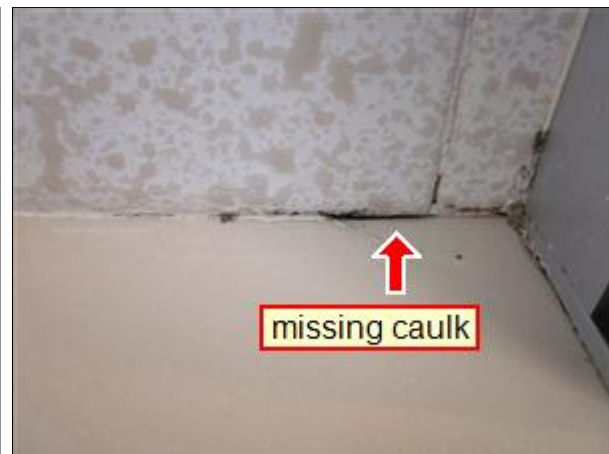
11.11 Picture 1

**11.11** The shower surround is missing grout in places and missing caulk around bathtub. This can lead to water intrusion and wall damage behind the tiles. This should be repaired as needed.

The shower surround is missing grout in places and missing caulk around bathtub. This can lead to water intrusion and wall damage behind the tiles. This should be repaired as needed.

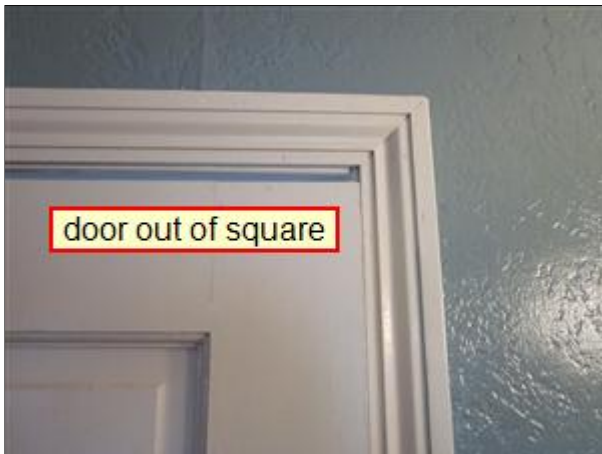
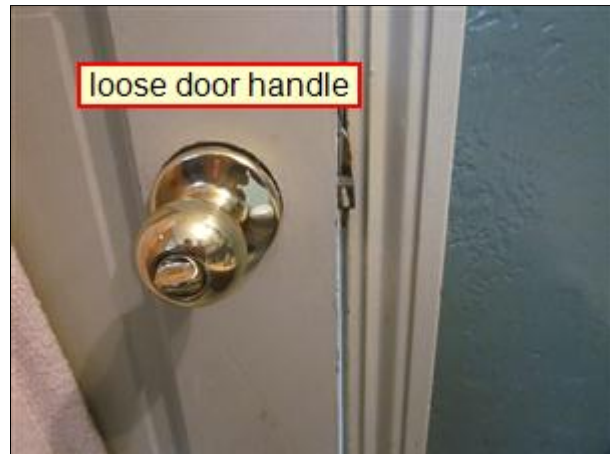
12.4 Picture 1

**12.4** The door to the guest bedroom rubs and needs adjustment. The door handle is also loose. A qualified contractor should inspect and repair as needed.

The door to the guest bedroom rubs and needs adjustment. The door handle is also loose. A qualified contractor should inspect and repair as needed.

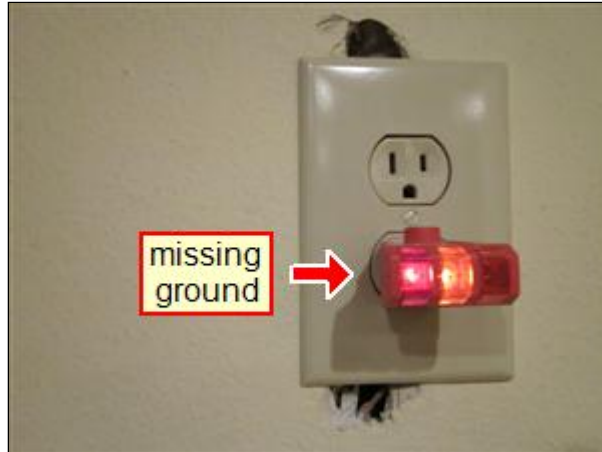
12.6 Picture 1

**12.6 (1)** One of the outlets in the living room is missing a ground. This is a safety hazard and should be repaired by a qualified contractor.

(1) One of the outlets in the living room is missing a ground. This is a safety hazard and should be repaired by a qualified contractor.

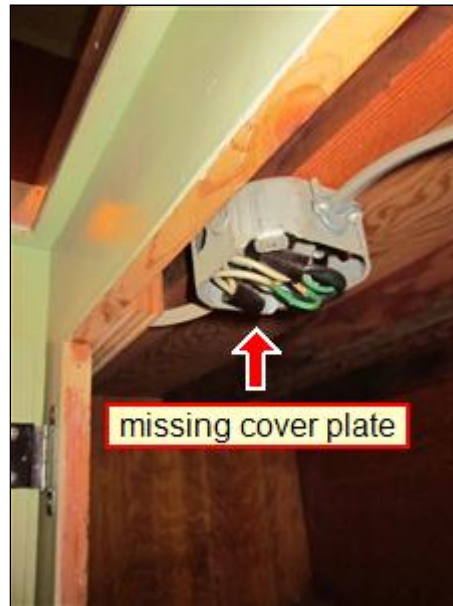
12.6 Picture 2

(2) There is a junction box in the hallway closet that is missing a cover plate. This is a safety hazard and should be repaired by a qualified contractor.

(2) There is a junction box in the hallway closet that is missing a cover plate. This is a safety hazard and should be repaired by a qualified contractor.
